# YOUR ONESURVEY HOME REPORT

2 Crumstane Farm Cottage  
Duns  
TD11 3LS

## **Structural Condition Report**

**2 Crumstane Farm Cottage  
Near, Duns**

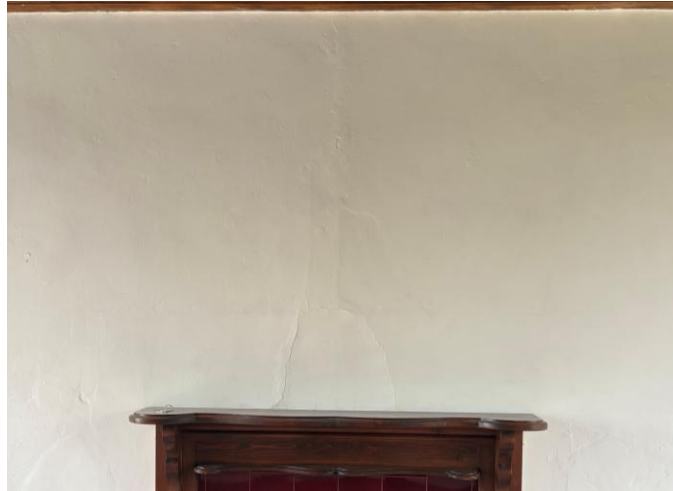
- 3.1 Hairline cracking and paper rucking were visible on the wall line directly above the fireplace within the lounge.

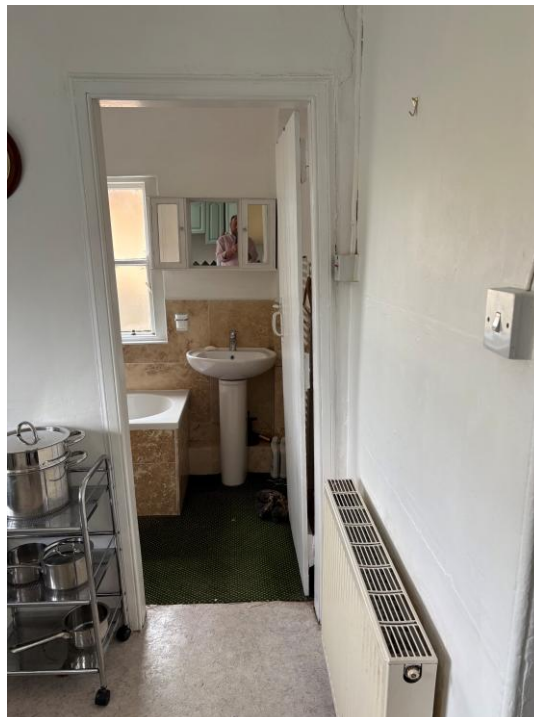
- 3.2 The kitchen floor seems to be level over half its plan width then has a cross fall to the rear external wall line and the left internal corner.
- 3.3 The bathroom door head falls from right to left, and the door standards are no longer plumb, having displaced away from the main cottage wall line. Although this wall is not loadbearing, it is of masonry construction.

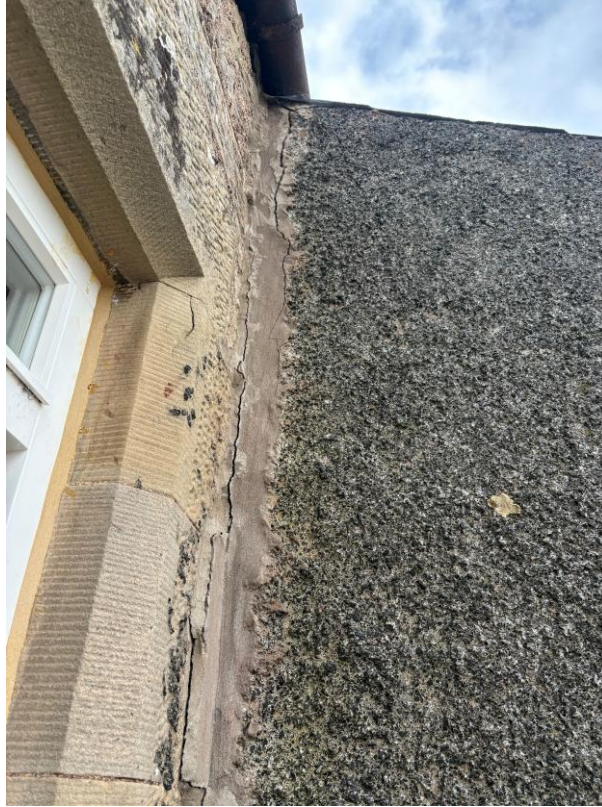
- 3.4 Externally, previous mortar packing was noted where the kitchen external walls abut the rear wall of the main cottage. This mortar packing is cracked, and its thickness suggests that the kitchen walls have debonded from the main cottage.

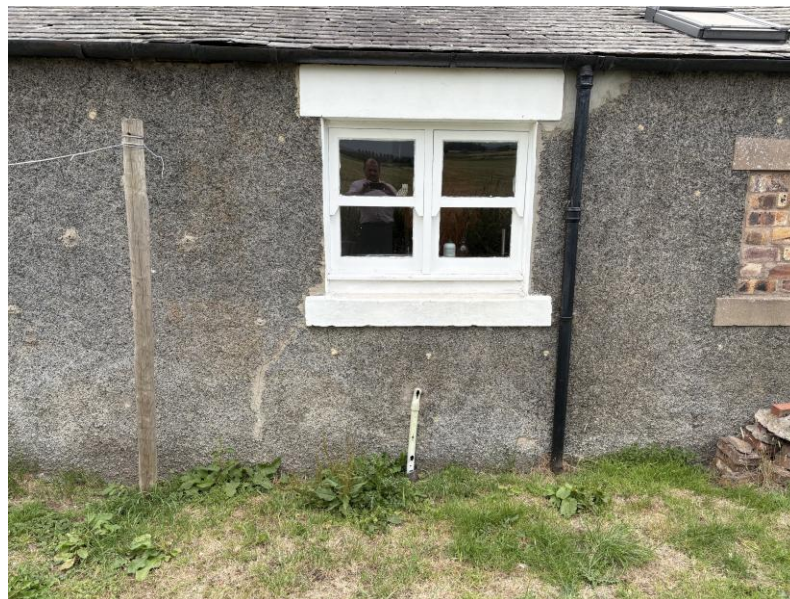
- 3.5 Hairline cracking was noted below the kitchen window.

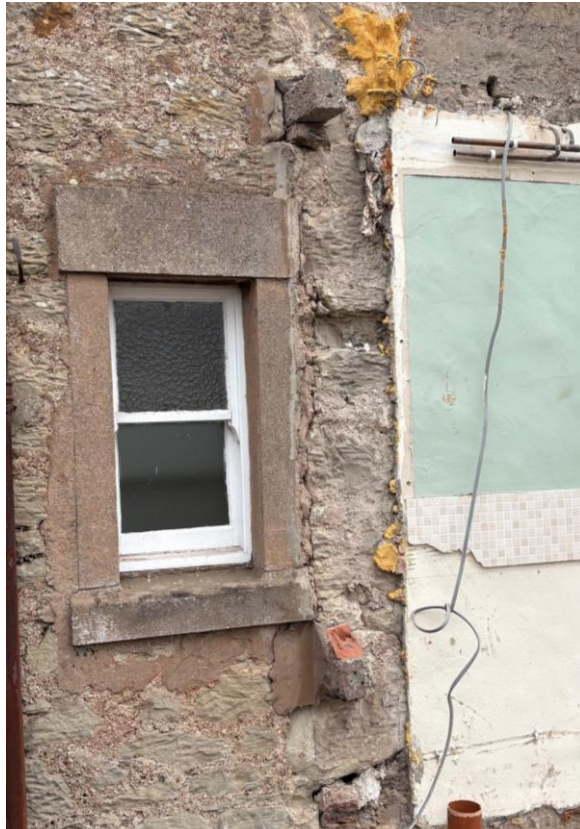
- 3.6 During the inspection, extension works had begun to the neighbouring property. These works provided insight into how the rear kitchen annexes were constructed and exposed the below-ground drainage arrangements serving the cottages.
- 3.6.1 We could see that the original wall lines had been poorly bonded to the original cottage with concrete lintels utilised at high and low level, appearing to only tie the external leaf.

- 3.6.2 The adjacent excavations highlighted a drain line close to the original rear cottage wall, which was likely made redundant when the kitchen / bathroom annexes were constructed. A further, newer drain line has been installed beyond the kitchen construction and at a reasonable distance, such that it is unlikely to have an adverse effect on the kitchen extension foundations.
