YOUR ONESURVEY  
**HOME REPORT**

9 Trinity Park  
Duns  
TD11 3HN

# SINGLE SURVEY

A report on the condition of the property, with categories  
being rated from 1 to 3.

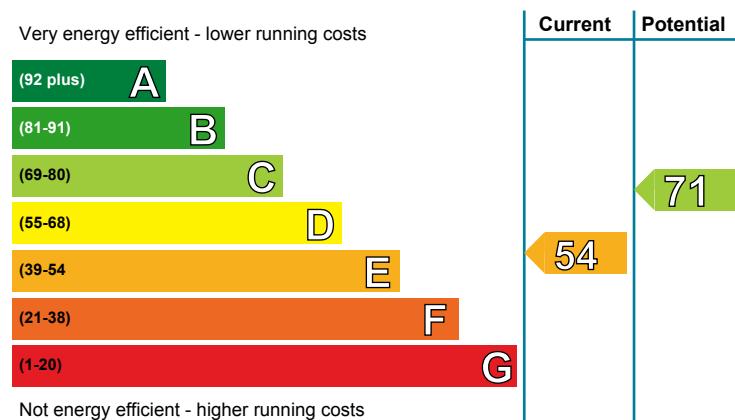
### Energy Efficiency Rating

This graph shows the current efficiency of your home, taking into account both energy efficiency and fuel costs. The higher this rating, the lower your fuel bills are likely to be.

Your current rating is **band E (54)**. The average rating for EPCs in Scotland is **band D (61)**.

The potential rating shows the effect of undertaking all of the improvement measures listed within your recommendations report.

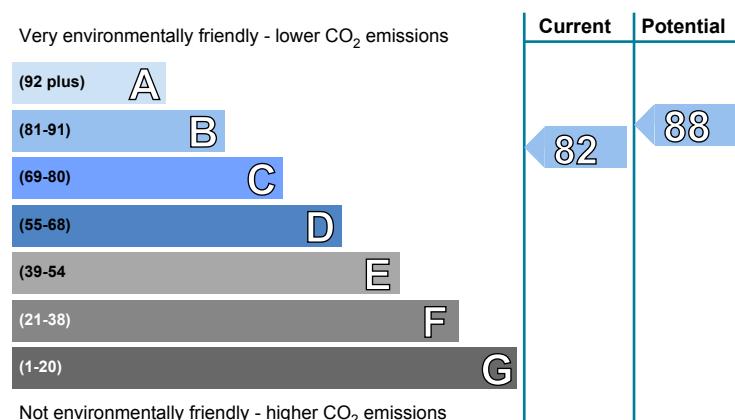
### Environmental Impact (CO<sub>2</sub>) Rating

This graph shows the effect of your home on the environment in terms of carbon dioxide (CO<sub>2</sub>) emissions. The higher the rating, the less impact it has on the environment.
