YOUR ONESURVEY
HOME REPORT

15 The Glebe
Gavinton
Duns
TD11 3QU

SINGLE SURVEY

Single Survey

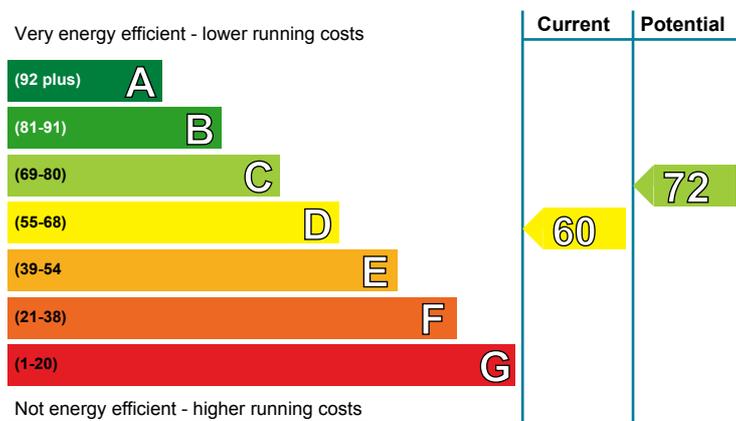
Energy Efficiency Rating

This graph shows the current efficiency of your home, taking into account both energy efficiency and fuel costs. The higher this rating, the lower your fuel bills are likely to be.

Your current rating is **band D (60)**. The average rating for EPCs in Scotland is **band D (61)**.

The potential rating shows the effect of undertaking all of the improvement measures listed within your recommendations report.

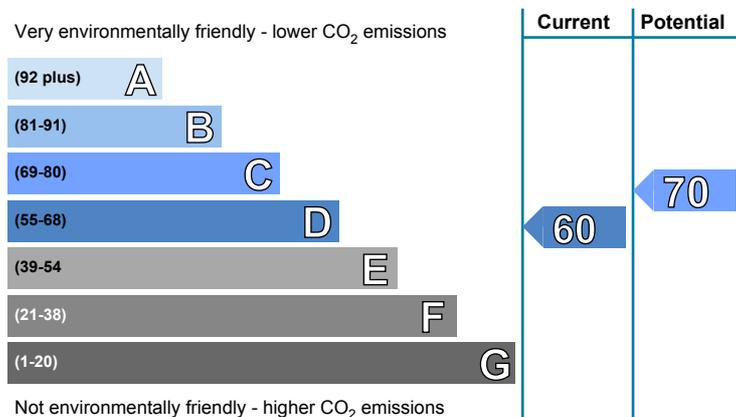
Environmental Impact (CO₂) Rating

This graph shows the effect of your home on the environment in terms of carbon dioxide (CO₂) emissions. The higher the rating, the less impact it has on the environment.
